re: **Newpark – Precinct 7 – Stage 7F**
Abell Road, Marsden Park
Site Classification Report

8599/113-AA-R1
Newpark Precinct 7 Stage 7F, Marsden Park

**DRAWING NO 8599/113-AA1
(*Test Pit Location Plan*)**

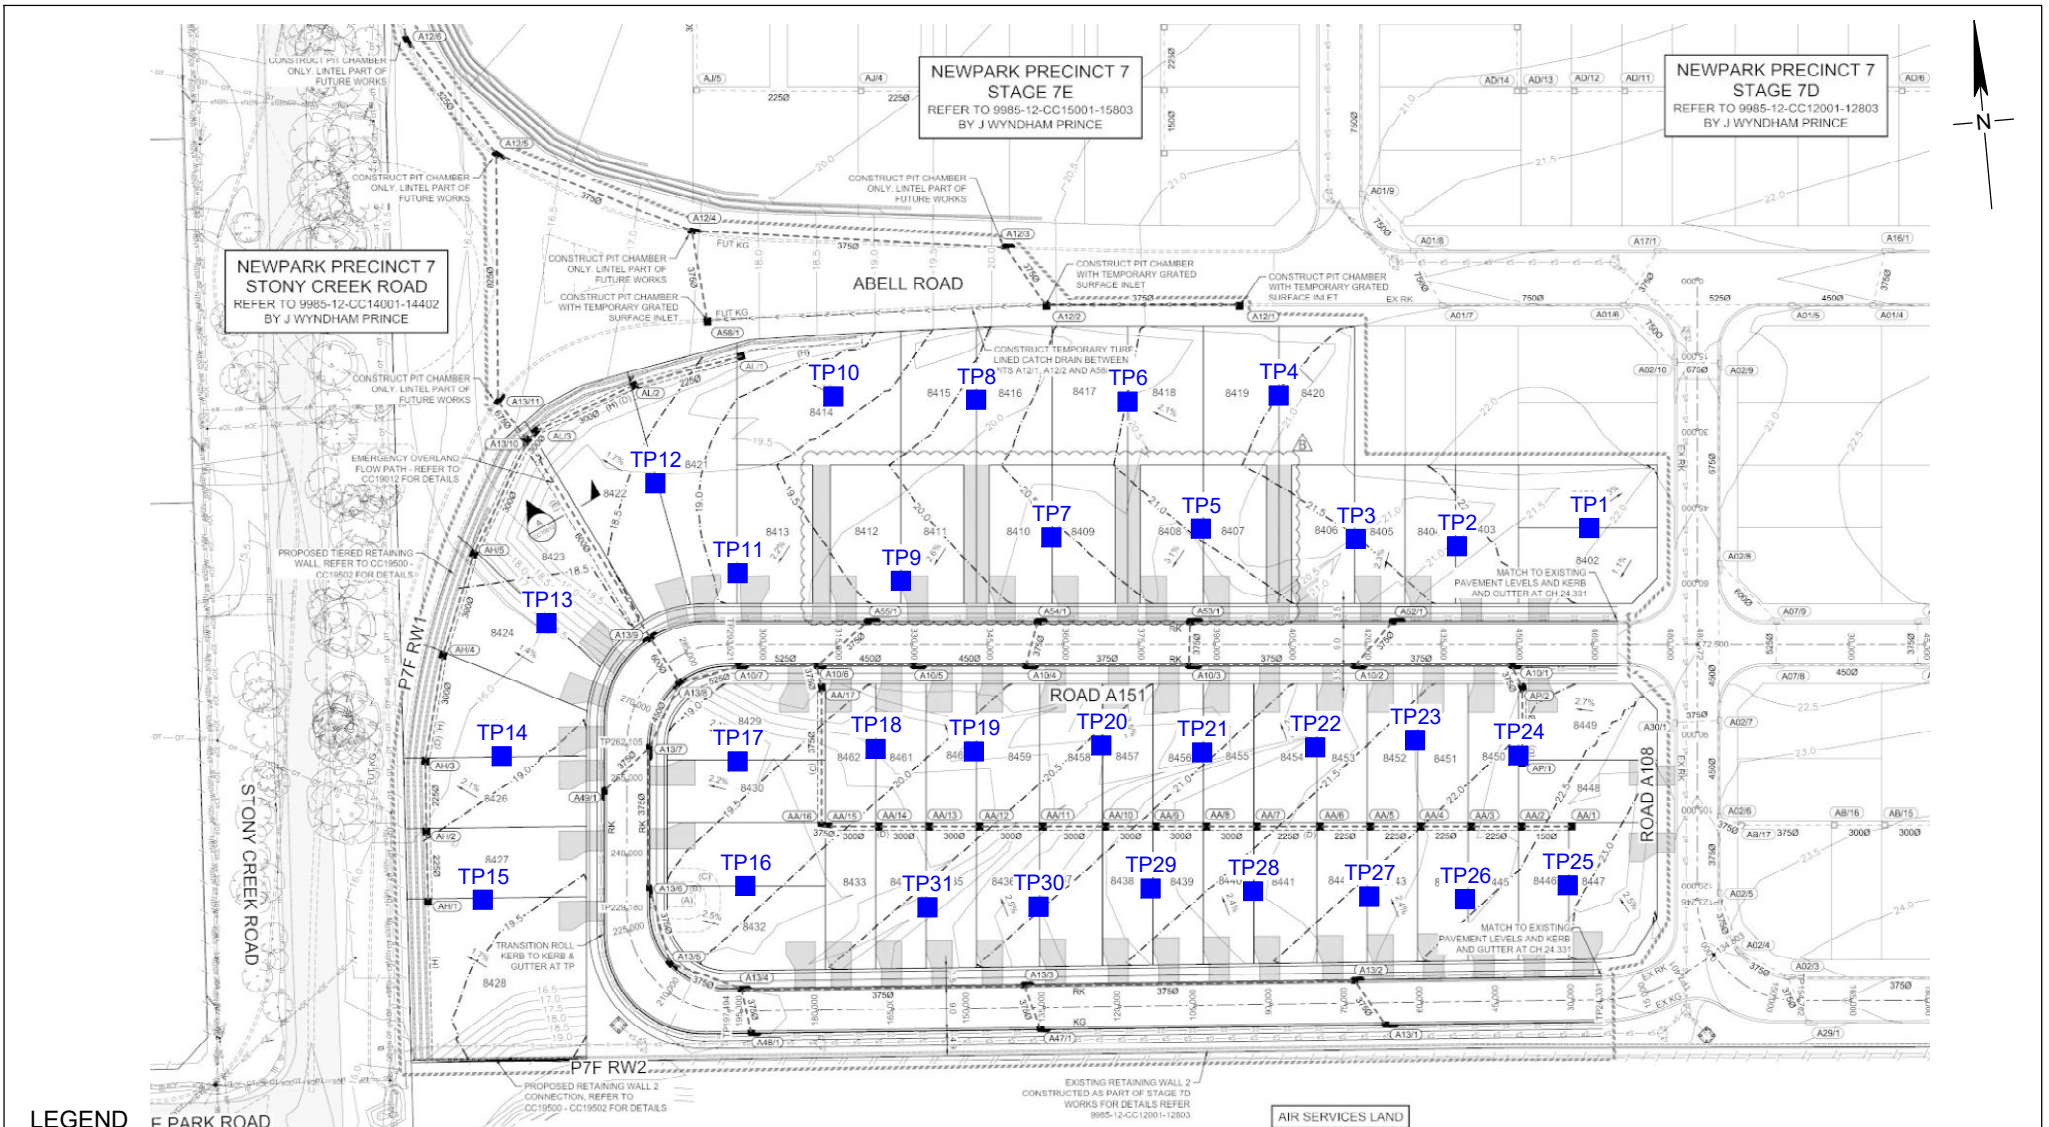
Drawing No: 8599/113-AA1
Job No: 8599/113
Drawn By: MH
Date: 19 September 2023
Checked By: JC

1. Site features are indicative and are not to scale.
2. This drawing has been produced using a base plan provided by others to which additional information e.g test pits, borehole locations or notes have been added. Some or all of the plan may not be relevant at the time of producing this drawing

Test Pit Locations

Field work for the investigation was carried out under the full time supervision of a Geotechnical Engineer on 13 September 2023 and consisted of excavation of thirty-one (31) test pits (TP1 to TP31) to depths of the order of 1.5m using a 5 tonne excavator. Test pits at shallow depths were terminated due to refusal on bedrock. The locations of the test pits are shown on the attached Drawing No 8599/113-AA1 in Appendix A. A summary of the field data obtained is presented in Appendix A.
